ElectroMagnetic Fault Injection Characterization

University of Amsterdam
System & Network Engineering MSc

February 10, 2014

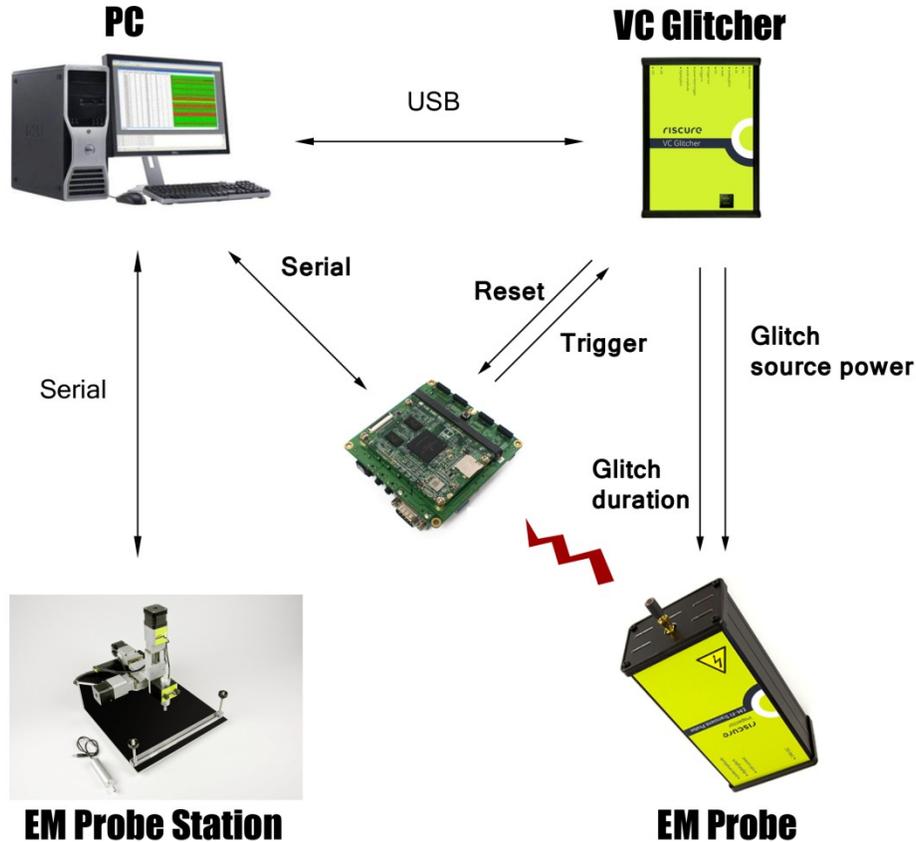
Figure 2.1: Schematic overview of the test setup

To perform the tests during the research, an EMFI setup was composed and used. This setup is illustrated in a schematic in Figure 2.1. A picture of the setup can be seen in Figure 2.2. Components of the setup include:

Riscure’s proprietary software, Inspector, is used to orchestrate all the other devices of the setup and record the results. It communicates through serial with the EM Probe Station in order to pass/receive coordinates, and with the target in order to issue the command to execute the test code and receive the result. It communicates through USB with the VC Glitcher in order to pass the glitching parameters.

It offers XY movement to the attached device. The attached device in this setup is Riscure’s EM Probe. The target is securely placed at the base of the EM Probe Station. The EM Probe Station offers a step size of $2.5\mu\text{m}$ and repetition error smaller than $50\mu\text{m}$ to allow test repeatability [9].

It is the main control unit during the tests. After the glitch parameters has been passed from Inspector it is responsible to generate the configurable glitch by passing the glitch duration and glitch source power parameters to the EM Probe when receiving a trigger signal from the target. In case the target becomes unresponsive, it sends a signal to the reset line of the target.

It generates the electromagnetic field by passing current to the coil attached to its end. The maximum voltage over coil is 450V (+/- 10%) and the maximum current through coil of probe tip (4mm tip) is 48A (+/- 10%). The EM pulse power can be controlled for 5-100% of total power. For reaching full power, a pulse width of at least 50ns is required [5].

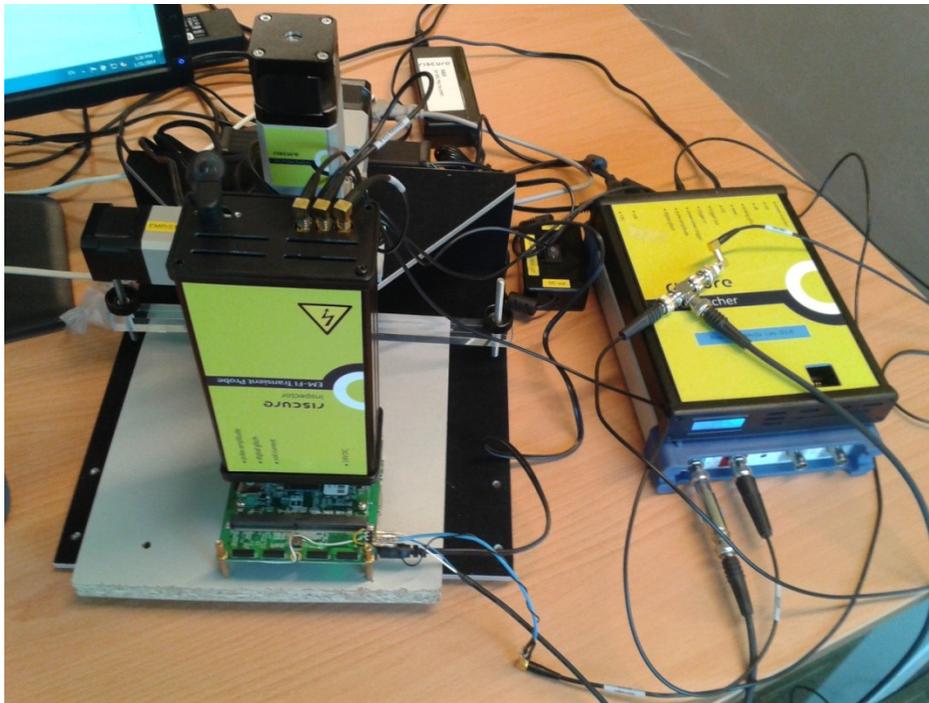
Figure 2.2: The EMFI setup

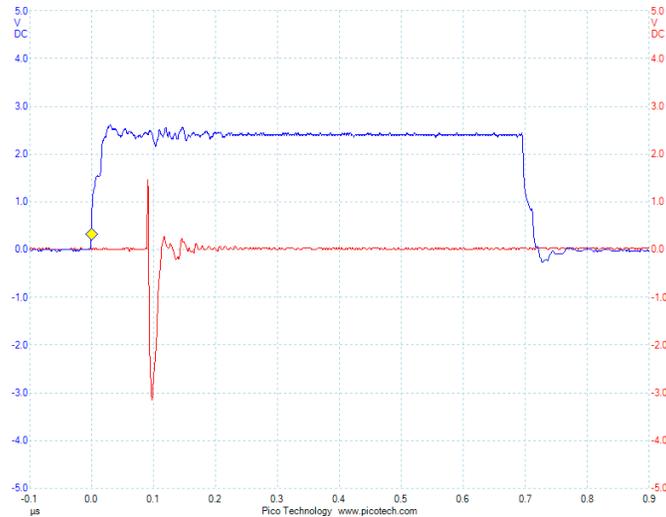
As seen on Figure 2.3, there was a delay between the time of the Trigger ON event and the time the glitch was instructed to take place (glitch offset set at 0ns) measured at around 90ns. To compensate for this, several NOP commands were inserted between the Trigger ON code and the Critical Code in order to delay the Critical Code's execution by at least 90ns.

Figure 2.3: Trigger signal(blue), Coil current(red)

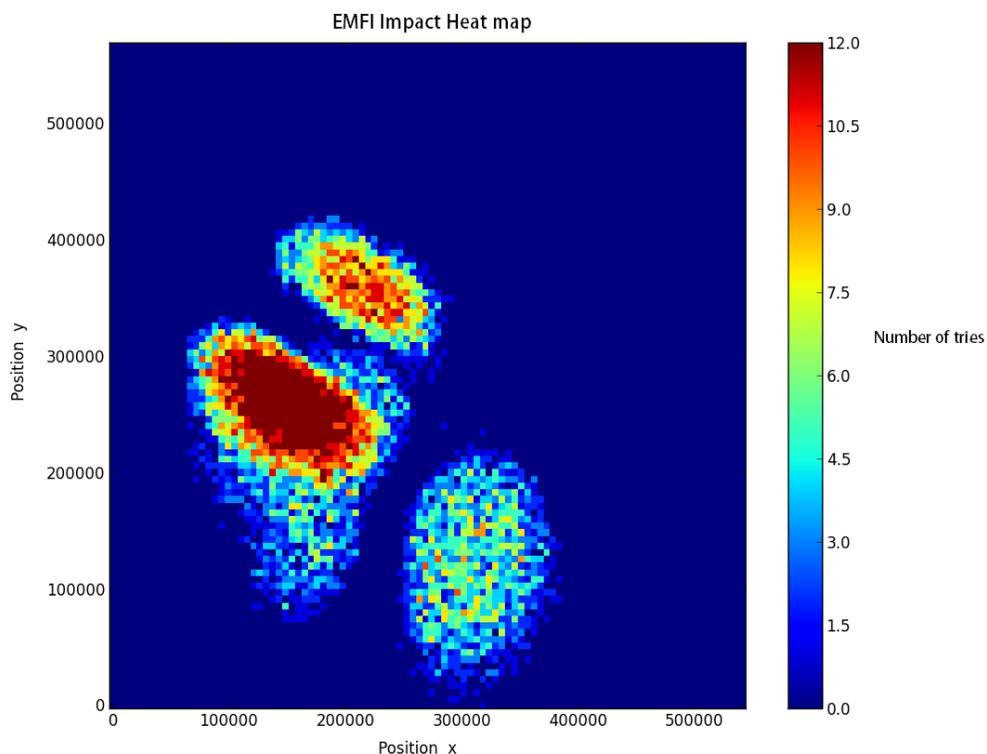
Figure 3.1: Full area scan heat map

Each colored square on the heat map represents a distinct region that was checked 12 times with different glitching parameters as mentioned in section 2.1. The color of the square represents how many glitches were encountered in total out of 12 tries. Three distinct areas are clearly standing out from the map. What caught our attention in this heat map is that the center of the chip, where we expect the die to reside, seems unresponsive. Further scanning of that area will be discussed in the next section.

The first scan is a scan of the whole area of the chip. The result is shown on Figure 3.1.

Another interesting comparison would be between the whole area heat map presented in Figure 3.1, generated when trying to glitch logical and shift instructions, and a heat map that would be generated when trying to glitch memory instructions. The comparison may show that different regions could be targeted in case a memory instruction glitch is required.

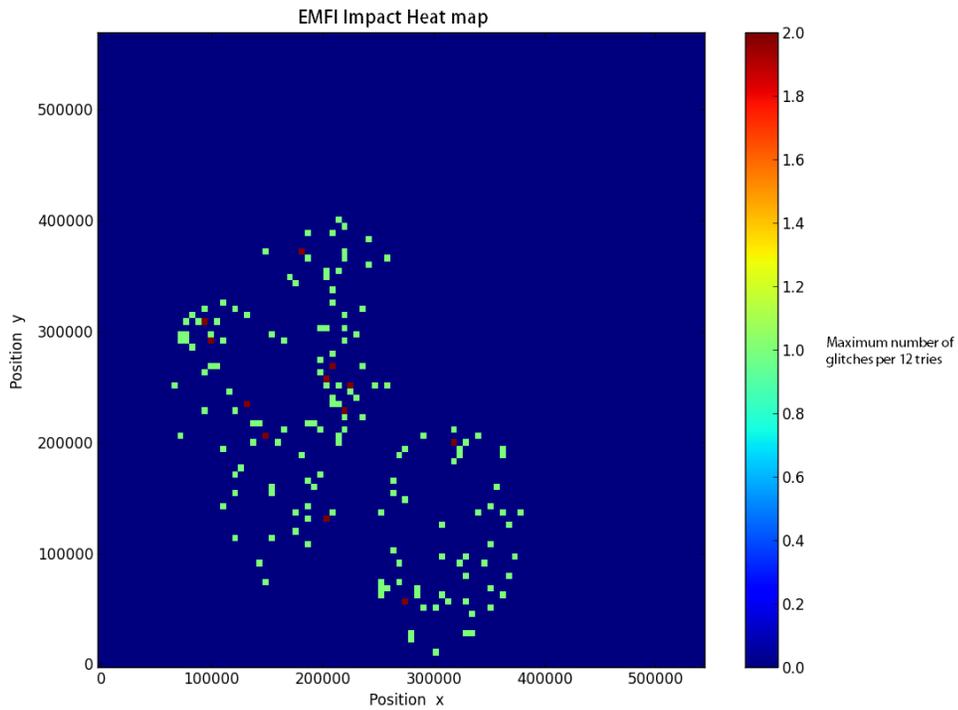
Figure 3.2: Filtered full area scan heat map

If we filter the results and keep only the Preferred Glitches the heat map in Figure 3.2 reflects the results.

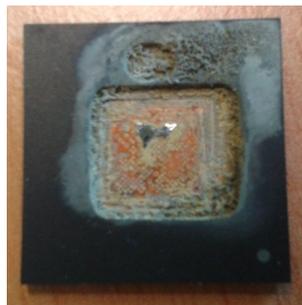
Figure 3.3: Decapsulated ARM Cortex-A9

Our next approach is to scan the area directly above the die with more power to the coil in order to see if we can get any glitches. In order to roughly aim this area and be certain that is indeed located in the center, an ARM Cortex-A9 decapsulated chip was used as reference. The decapsulated chip is shown in Figure 3.3.

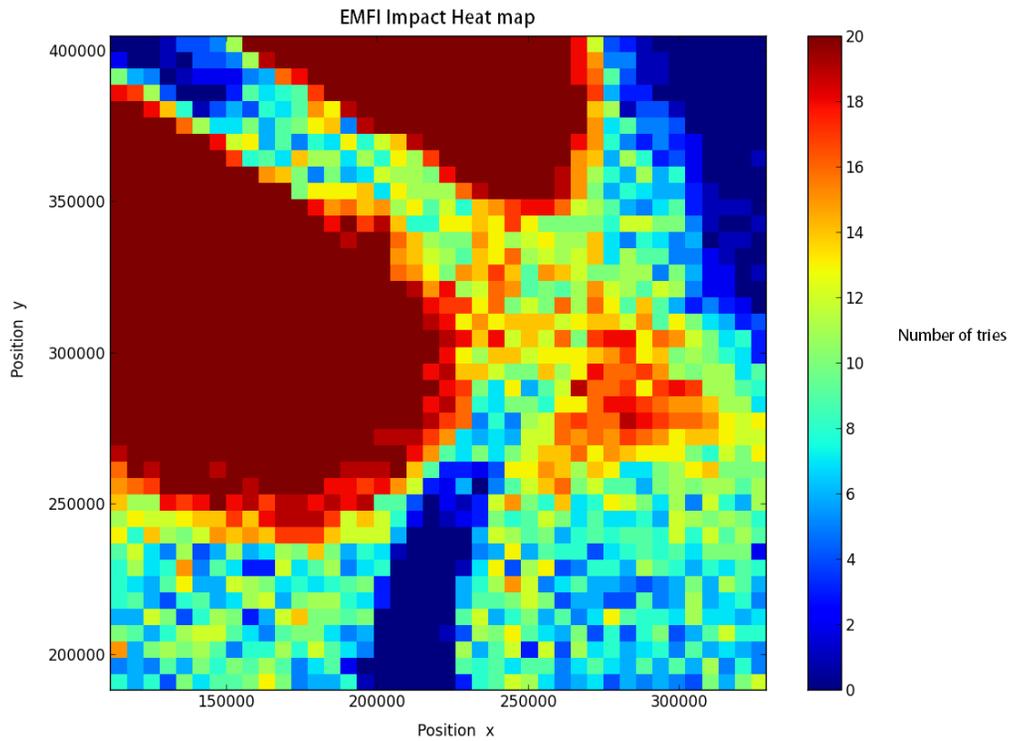
Figure 3.4: Scan of the die area heat map

It should be noted that the distinct deep red areas, though they seem interesting on the heat map they are mostly producing Mutes. An attempt to scan them with lower power produced Mutes or no glitches at all.

The scan results can be seen in Figure 3.4.

- The outer edges of the die are more sensitive than the center of the die. More voltage was required in the coil in order to get glitches from the die area (Figure 3.4).
- Preferred glitches can be found in multiple areas of the chip and not exclusively in the center of the die as shown on Figure 3.2. This could prove useful in case the die cannot be targeted directly or the magnetic field cannot reach the semiconducting material due to extra layers of package atop the die.
- The red area depicted in Figure 3.5 is the area inside the die that Preferred glitches are likely to take place. This will be the main target area for further tests. Results will be gathered and examined mainly from this area.

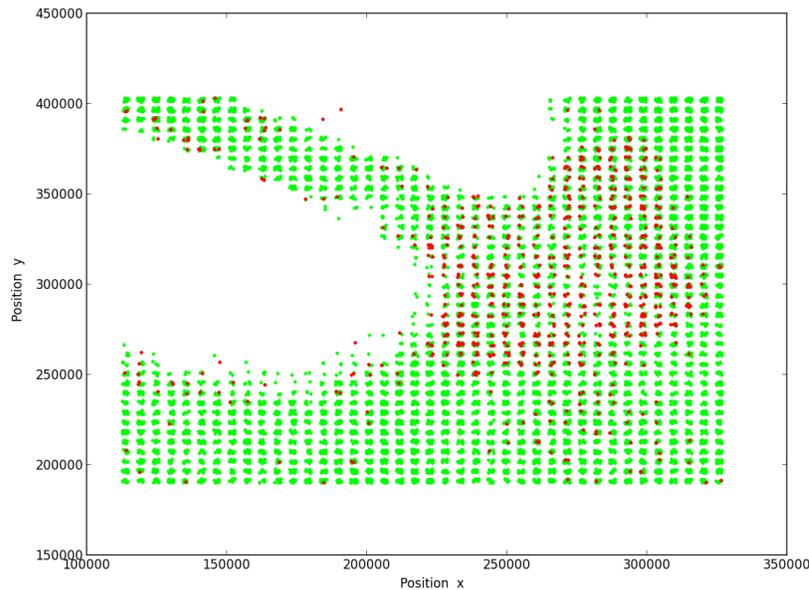
Figure 3.5: Area of Preferred glitches inside the die

In Figure 3.5 we see the area where Preferred glitches are present with red dots.

The green dots represent areas where no glitch was encountered. They are present in the diagram in order to give an outline of the scanned area and provide a distinction between the red and white dots.

The white dots (remaining white space) represent mostly Mutes and some General glitches.

If we again filter the glitches for the Preferred glitches we get the following result shown on Figure 3.5. A different diagram other than heat map was used to better distinguish the location on the die.
